# Manhole Inspection Summary

Manhole # S37CC\_006MH

Insp Date: **10/23/07 2:17 PM**

**Location** Address: **800 EAGER ST**

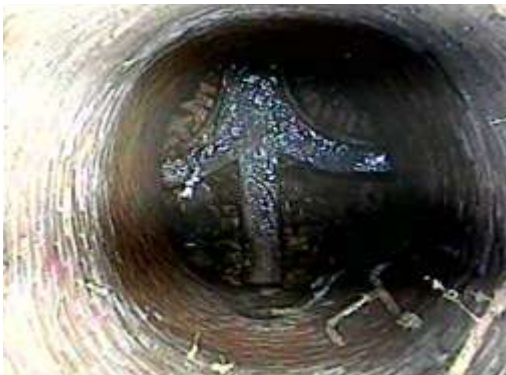
Defect 1

Count: **8** Missing: **3** ☒ **Corroded**

STEPS CORRODED

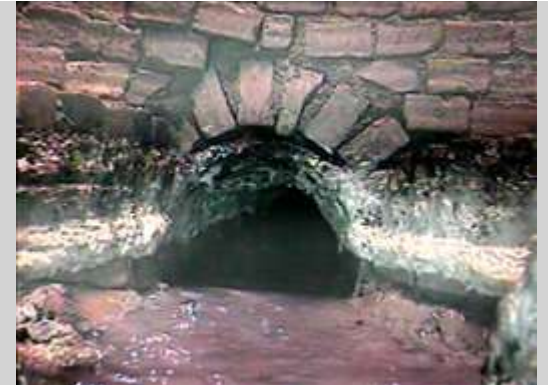
12 O'Clock Outflow

10 in. Circular Gravity Sewer  
Pipe Out @ 12 O'Clock

Pipe Height: **6** (in.) Rod and Bar  
Pipe Material: **Clay** ☐ Pipe Lined  
Invert Depth: **11.92** (ft.) Flow Characteristics: **Fast**  
Deposits: ☐ None ☐ Mud ☐ Gravel ☐ Debris ☒ Grease  
Silt Depth: **0** (in.) Deposits Extent: **Light**  
Infiltration: **None** Pipe Seal Cond: **Unknown**

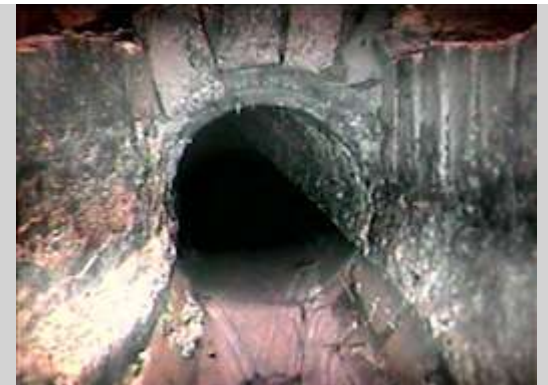
3 O'Clock Inflow

8 in. Circular Gravity Sewer  
Pipe In @ 3 O'Clock

Pipe Height: **4.8** (in.) Rod and Bar  
Pipe Material: **Clay** ☐ Pipe Lined  
Invert Depth: **11.70** (ft.) Flow Characteristics: **Fast**  
Deposits: ☒ None ☐ Mud ☐ Gravel ☐ Debris ☐ Grease  
Silt Depth: (in.) Deposits Extent:  
Infiltration: **None** Pipe Seal Cond: **Sound**

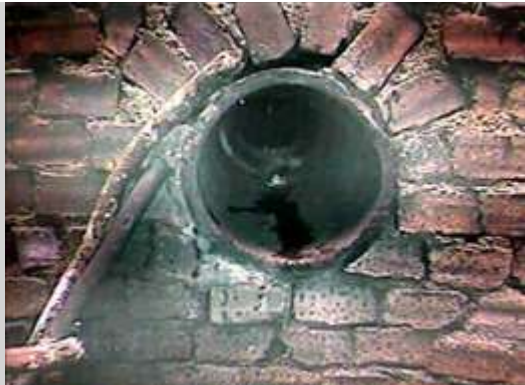
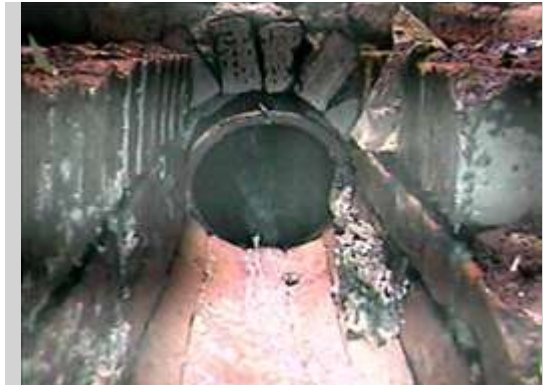
6 O'Clock Inflow

Pipe In @ 6 O'Clock

Drop In @ 6 O'Clock

Deposits: ☐ None ☐ Mud ☒ **Sludge** ☐ Debris ☐ Grease

Silt Depth: **0** (in.) Deposits Extent: **Light**

Drop: **Outside Direct**

Drop Condition: **Open**

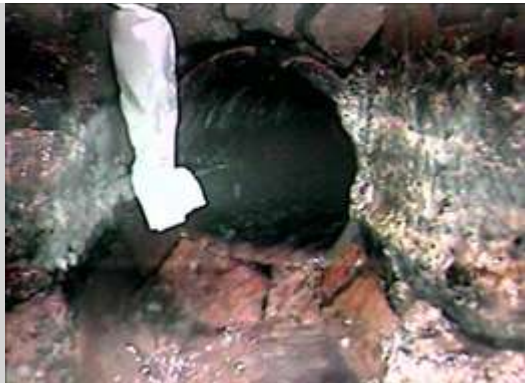
9 O'Clock Inflow

Pipe In @ 9 O'Clock

Infiltration: **None** Pipe Seal Cond: **Broken**
